Alpay Zeren, Alpha Teknoloji, Türkiye

## BETWEEN HOT KILN SURVEYS

A hot kiln alignment is normally performed once every 1-2 years. Routine measurements between these surveys can help maintenance teams identify changes earlier.

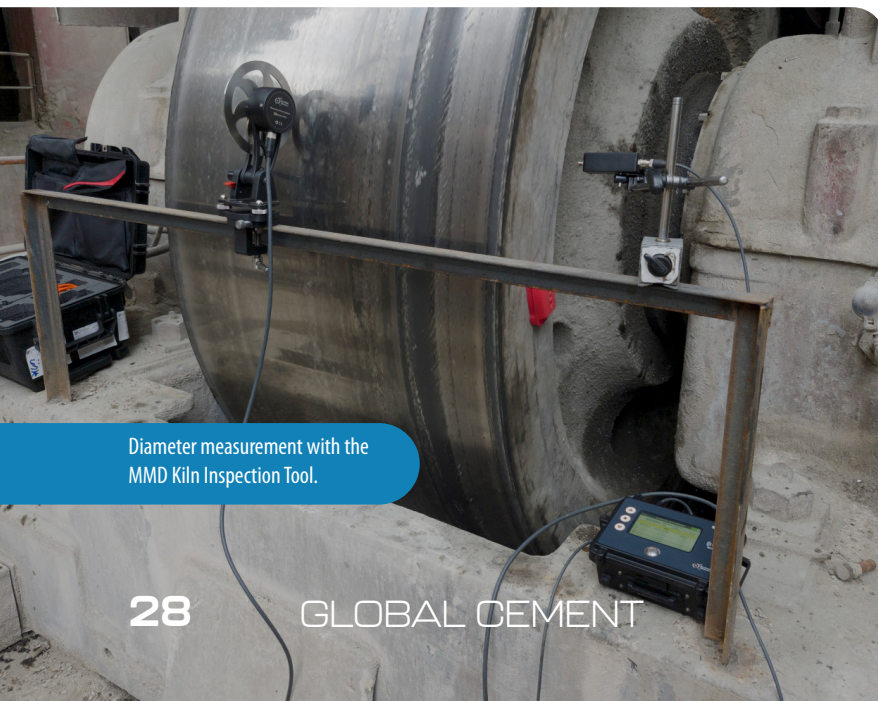
Diameter measurement with the MMD Kiln Inspection Tool.

For tyre diameter and migration work, the measuring wheel is placed against the rotating surface. The diameter result is shown on the device. Migration is then determined from the relative movement between the tyre and shell reference during one full revolution.

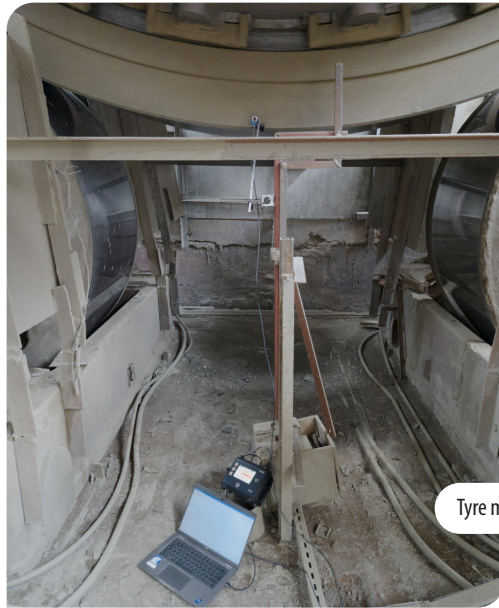
Tyre migration testing.

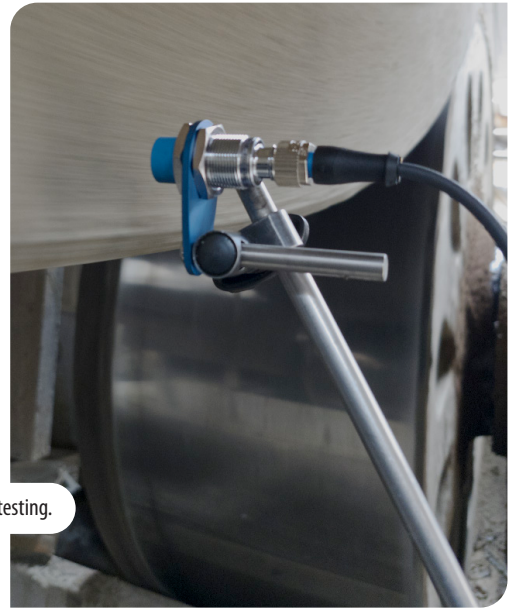
The MMD Kiln Inspection Tool is a portable measurement system for rotary kilns, dryers and similar rotating equipment. Depending on the setting, it can be used for tyre migration, tyre diameter, tyre axial run-out, roller shaft deflection and girth gear axial and radial run-out. Inductive sensors are used for close-range displacement measurements. A laser sensor can be used where access is difficult or where a non-contact measurement is preferred.
